**Spiral Weld**  
LIMITED

Re-engineering with Advanced Recovery Technology

**THE FIRST NAME IN RECOVERY TECHNOLOGY**

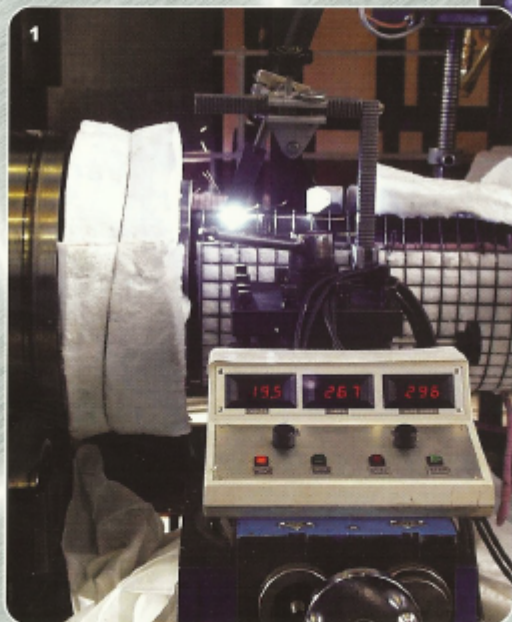
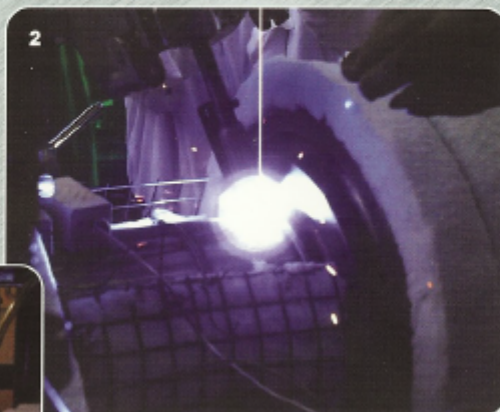
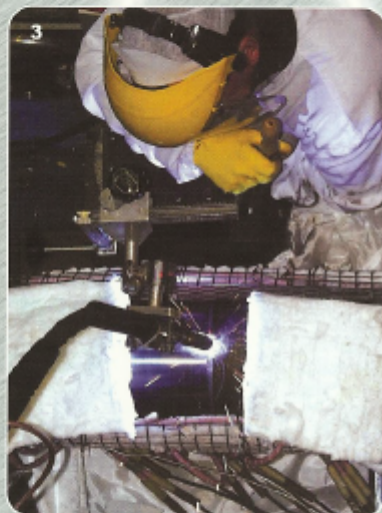
1-3 On-site recovery of a low level irradiated AGR gas circulator rotor with a replacement value in excess of £500,000. Job included recovery of:

- Bearing journals
- Pressure Boundary gas seal faces
- Bent rotor shaft

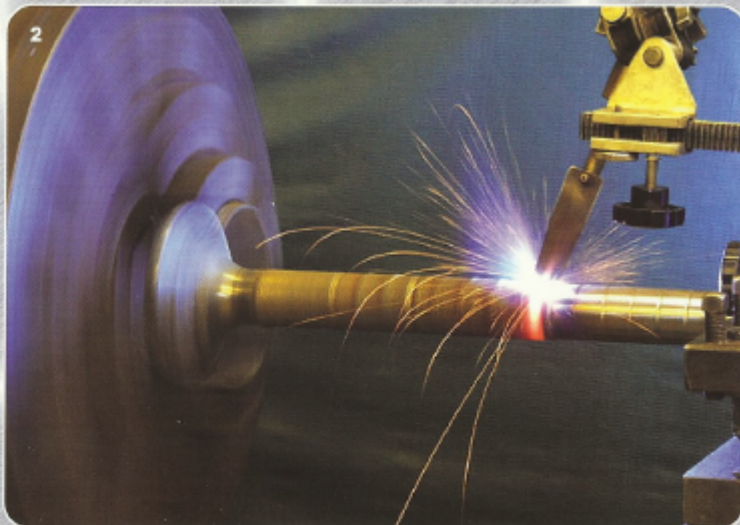
1. Recovery of worn contact areas of a main boiler feed pump and start standby boiler feed pump balance assembly.

Damaged areas are machined to sound/clean parent material, rebuilt using the Spiral Weld process and finished machined to original or customer required dimensions.

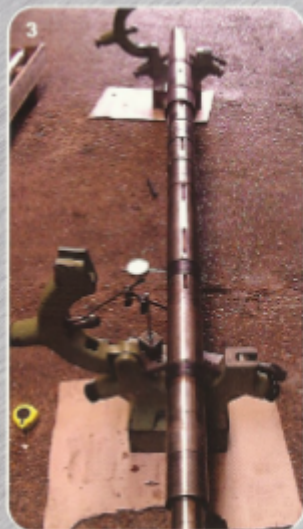
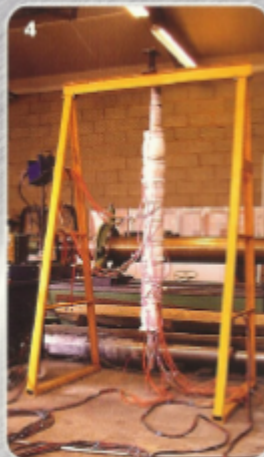
3-4. Start Standby boiler feed pump shaft undergoing initial inspection to damaged impeller location diameters and lip seal areas prior to Spiral Weld repair.

Following Spiral Welding, feed pump shaft is suspended vertically for post weld heat treatment of weld repaired shaft.

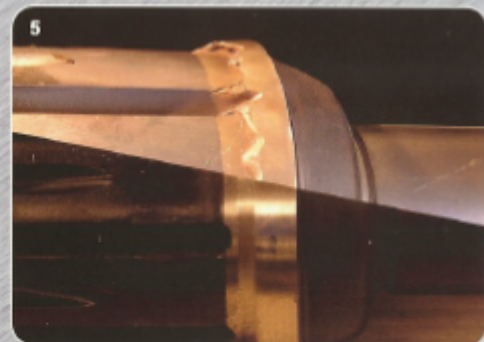
5. Control valve spindle showing eroded seat area in top half of picture and recovered seat in the bottom half. The seat was recovered with a cobalt based alloy to give the seat better wear resistance compared to the original design in parent material.

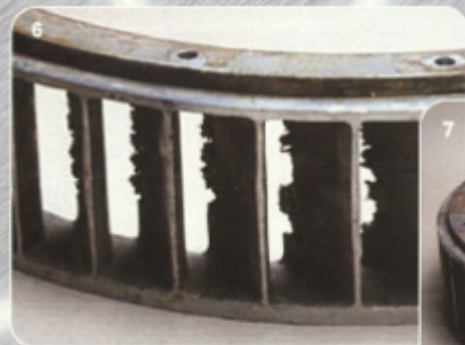
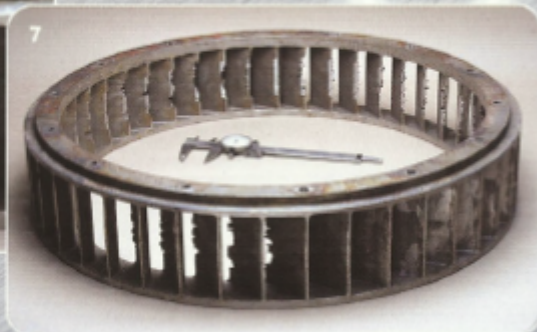
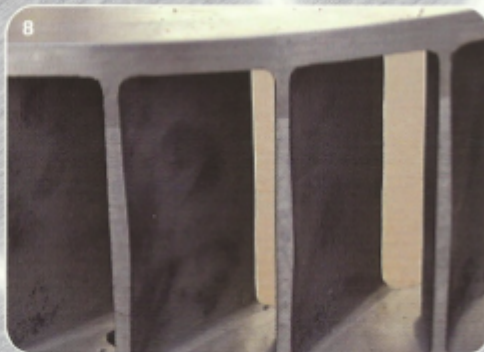
6-8. Worn rotary air pump vaned wheel showing damage to vane tips caused by in-service running hours. A specially developed weld solution was created to recover the vane tips back to serviceable condition.

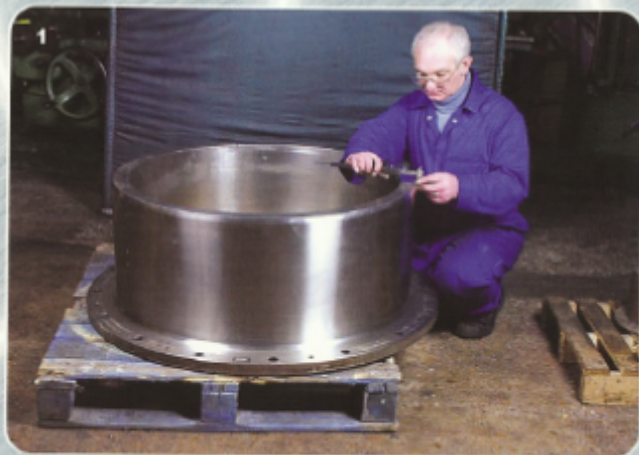
1. 900mm diameter tail shaft liner undergoing dimensional checks. Liner material is 316 stainless steel with a spiral weld overlay of Inconel 625 along the outer diameter to increase wear resistance against the seal arrangement and prolong in-service life expectancy of the liner.

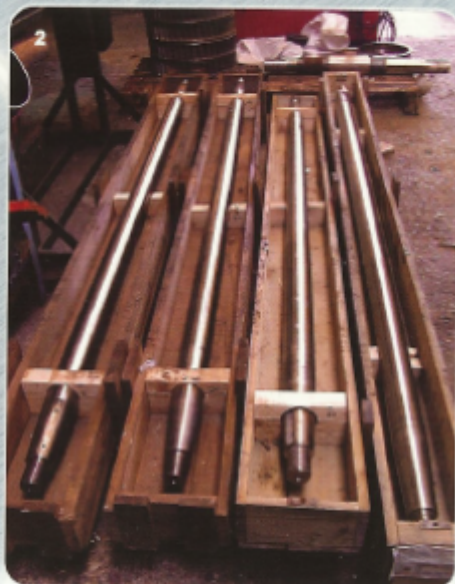
2. Prop shafts awaiting despatch following recovery of worn bearing and gland areas. We have extensive expertise in recovering carbon steels and more exotic materials such as Monel and Aquamet 22. Dissimilar overlays for improved performance are often used for the recovery using materials such as Inconel 625, Nitronic 50 and cobalt based alloys.

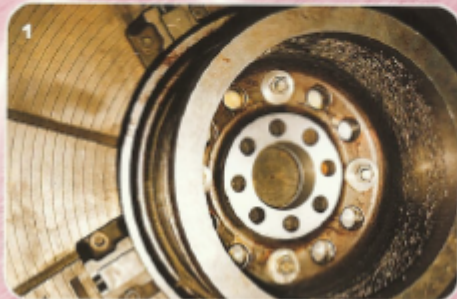
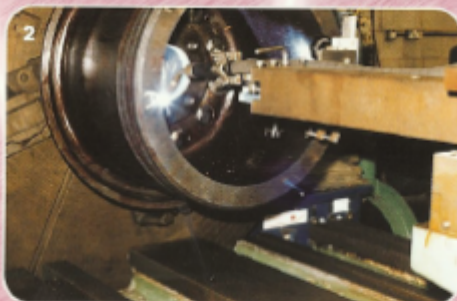
1-2. Recovery of an internal location diameter on a damaged valve head. Our low heat input process allows us to recover components with the minimum of distortion to surrounding features.

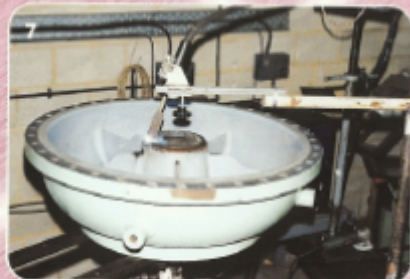
7. Carbon steel contactor head having the internal bore and seal area recovered with Hastelloy C22 to prevent corrosive attack from the process chemical.

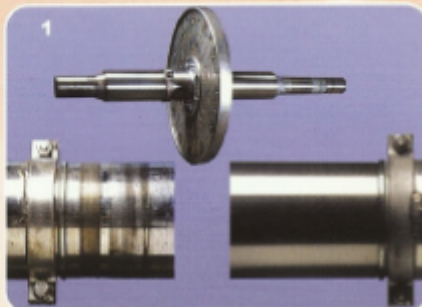
1. Process rotor following recovery of worn gland areas. Left side of the picture shows gland area prior to repair, right side of picture shows gland area following repair.

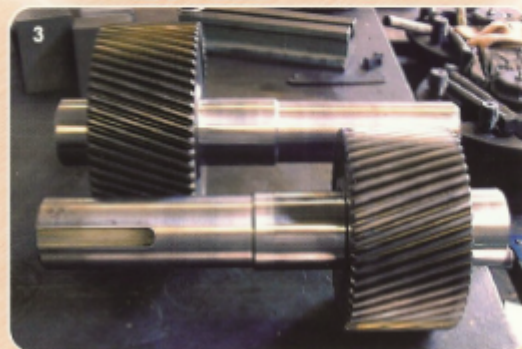
3. Typical gear wheels have had worn bearing diameters recovered either side of the gear hubs.

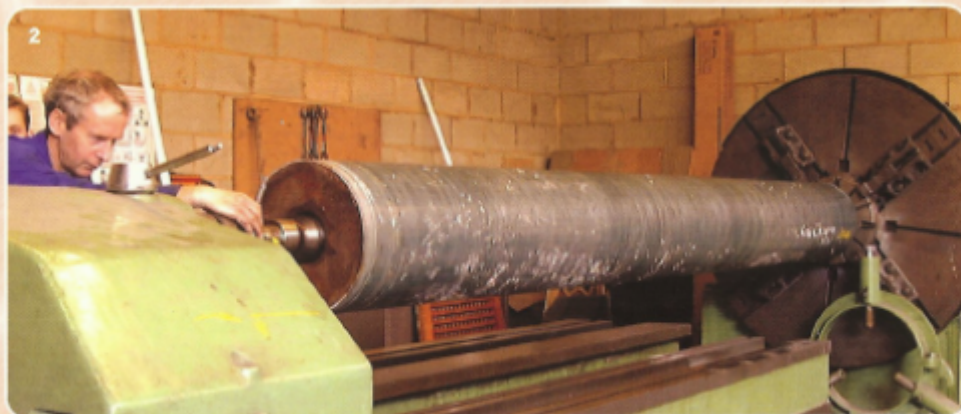
2. Process roller from a paper mill having the damaged bearing areas recovered at either end of the roller.

These areas were recovered without the need to remove the stub shafts from the roller body.

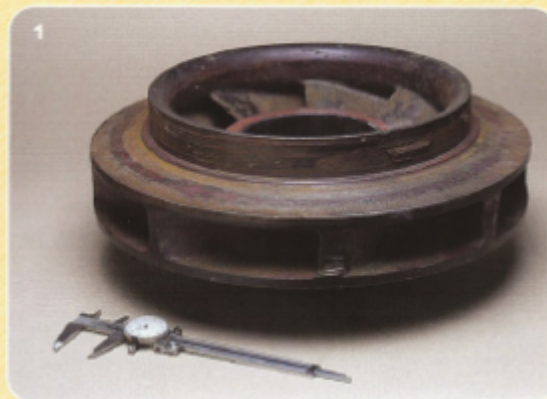
1. shows worn and corroded impeller on arrival at our service centre. The impeller required recovery of the neck ring diameter, hub and bore diameters and vane tip leading edges.

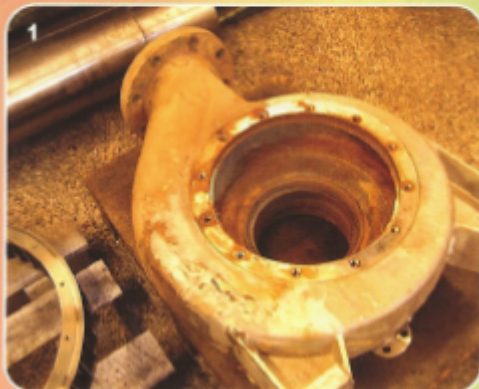
1-2. Hastelloy pump casing with location spigot and gasket face eroded and corroded by the chemical being pumped. Spiral Weld repaired using Hastelloy alloys to recover the worn location spigot and gasket face.

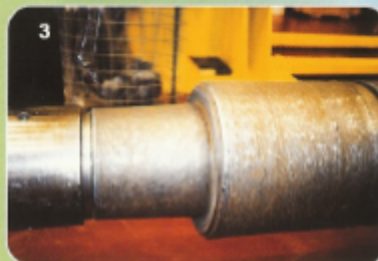
3. Major rotor shaft recovery

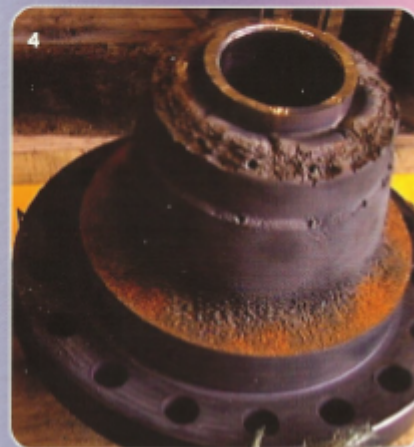
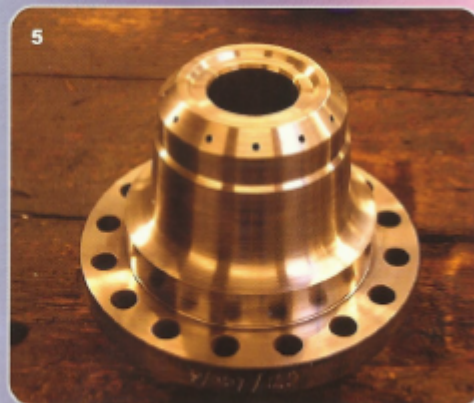
4-5 Worn control valve spray nozzle eroded by high pressure/high temperature water. Component has a cobalt alloy insert bush for increased wear resistance in the spindle guide area. Spiral Weld will either recover these nozzles by welding, or manufacture a new component, including overlaying the guide bush area with a cobalt alloy.
