This is an extract taken from the IMechE international conference on power station maintenance 2000:

Spiral welding — cutting the cost of maintenance, but not the quality.

S F CLARKE, G LINDSELL, and B PAYNE: SpiralWeld Limited, Southampton, UK

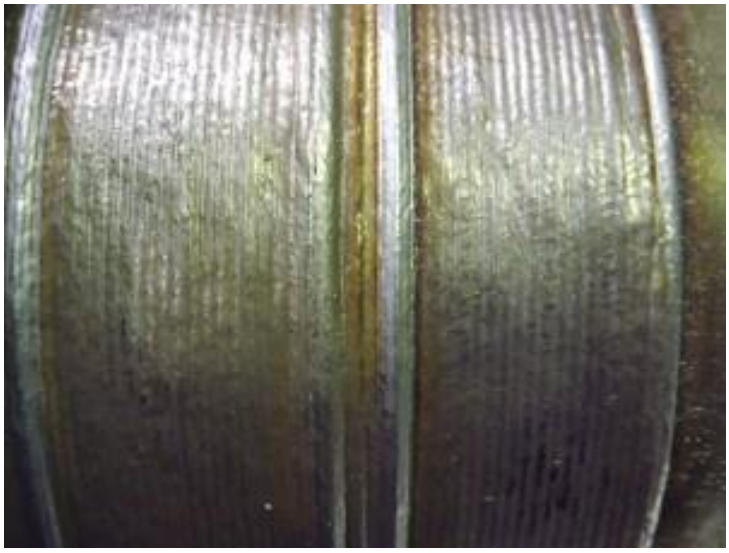
Fig 1 Close up of weld overlay

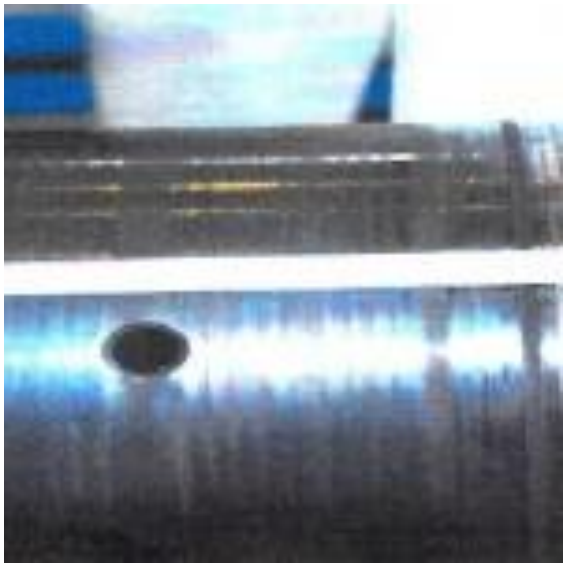
Having now established that the spiral weld recovery process was a complete success, the next stage was to carry out the repair of the actual rotor. The rotor was mounted in a lathe and the worn areas pre machined. (See fig 5 below).

Fig 5. Damaged AGR gas circulating rotor bearing journal

Upon completion of pre machining the rotor was prepared for welding. A pre heat of 225 Degrees C was selected. Due to the dimensions and material of the rotor it was crucial that this temperature was maintained during the complete welding cycle. The rotor was wrapped in a specially designed insulated ceramic-heating jacket, with minimal access allowed for the welding torch. On completion of the weld the rotor temperature was raised to 300 degrees C and the rotor lifted into a vertical position to carry out the PWHT.

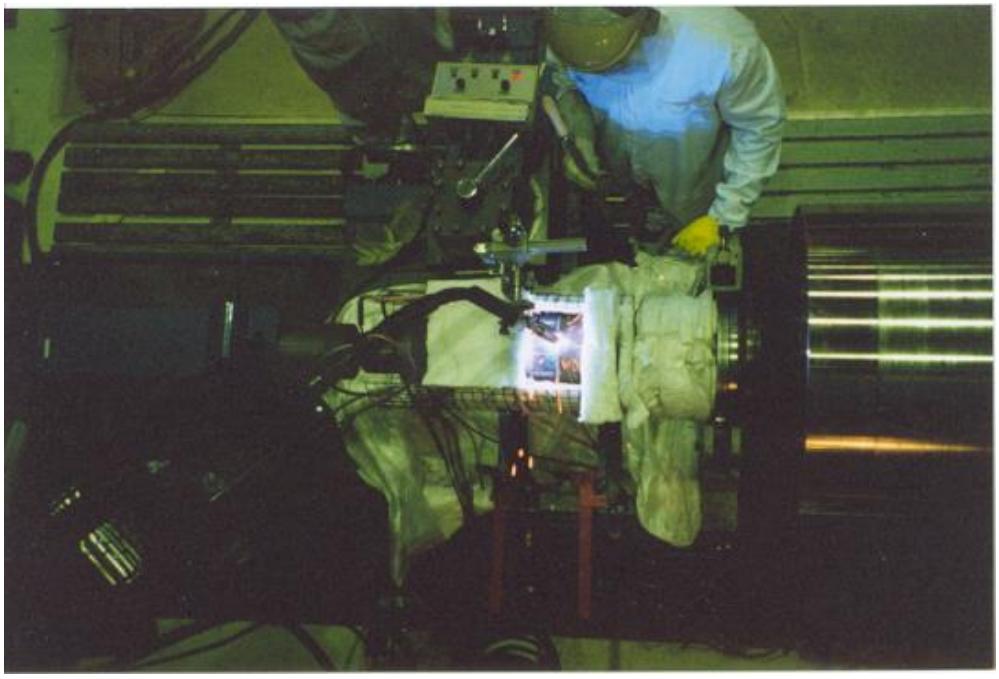
Fig 6. Rotor undergoing welding

The rotor temperature was increased at 50 degrees C per hour to a maximum temperature of 620 degrees C + or – 10 degrees. This temperature was maintained for 7 hours (1 hour per 11= diameter) The rotor cooling rate was controlled at 50 degrees C per hour down to 250 degrees C and then the thermal insulation removed for cooling to ambient. The rotor was then reset into the lathe, checked for concentricity and proof machined to + 0.020" on final dimensions to establish weld integrity by full NDT as per the original test samples.
